# Surface irregularities in titanium marine parts formed by the particulate injection moulding process

In this study, a structural hold down component was designed and produced using the particulate injection moulding (PIM) process. The material of choice was titanium due not only to the material properties but also due to the desire to create custom-made components for a state-of-the-art marine vessel, Earthrace 2.

On removal from the mould, the green parts were seen to have an irregular surface on the top face. Known as surface bloom, it can be seen during moulding of single-phase commodity polymers as a result of changes in the polymer density, due to shear stresses and irregularities of turbulent flow.

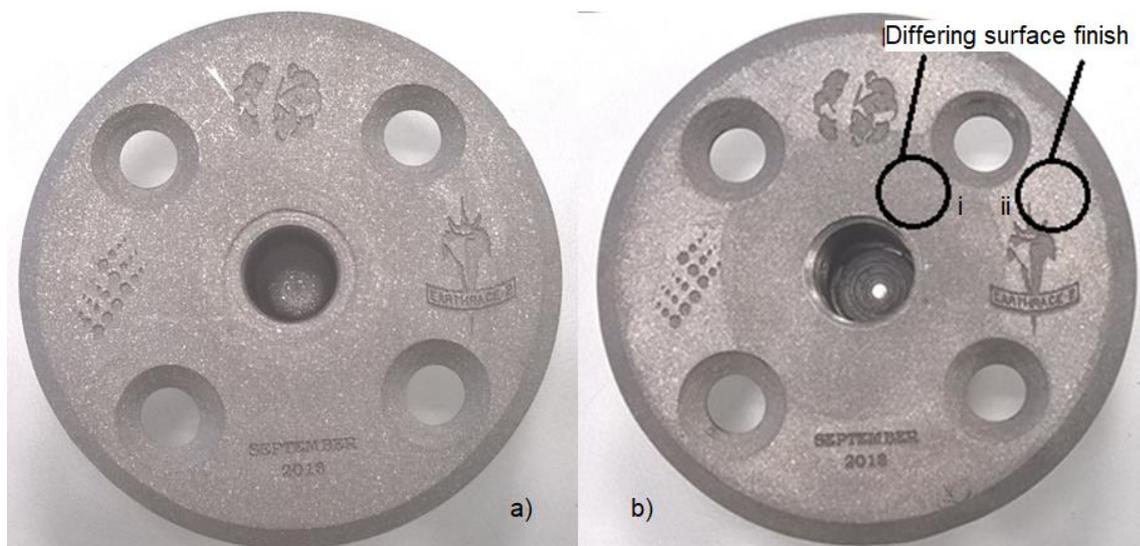
An unexpected result of reducing the wall thickness was an irregularity seen on the upper surface of the mount. The irregular surface appeared in no particular order during moulding and was seen to stay in the part through all processing steps (Figure 1 b)). The irregular surface was seen in 10 of the 28 parts that were moulded. The concern being whether the visual phenomenon would affect the microstructure and/or mechanical properties of the part in use. A similar visual can be seen during plastic moulding of single-phase commodity polymers and is known as surface bloom [5]. It is proven to be a result of changes in the polymer density and separation of components due to shear stresses, incompatibility and irregularities of turbulent flow.

*Figure 1: The sintered titanium part a), and b) the part with surface irregularities (i & ii) on the top face*

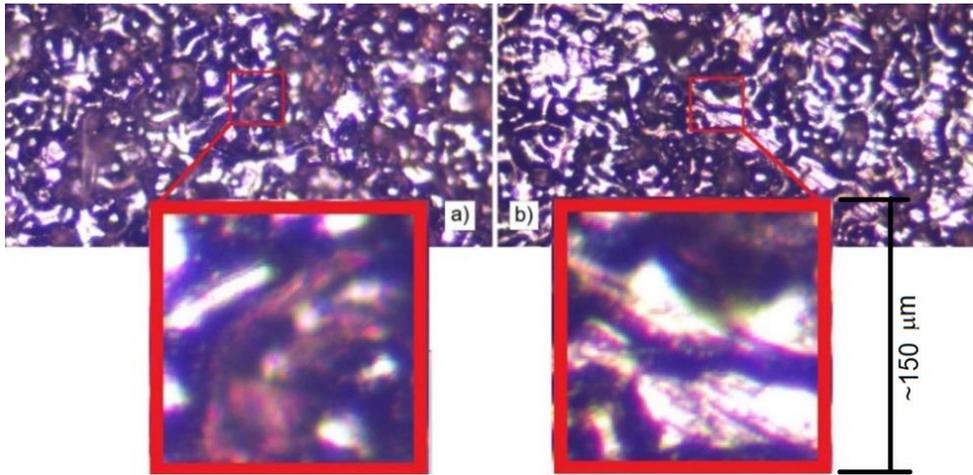
The regular surface was that with the greatest area of coverage on the parts. Figure 5 shows magnified images of the sintered part surfaces, irregular (Figure 1 b i) and regular (Figure 1 b ii). While particle counts are an often selected means to objectively evaluate disparity over a given area, the equipment available in this work was not suitable for this. The irregular surface finish as seen on the top face of the part is considered a processing defect. It is the nature of the defect that is being investigated. If the defect is seen throughout the part's cross section, it is a structural defect and may have a critical influence on the mechanical properties and the part would require a redesign, mould flow optimisation and retooling. As a cosmetic defect, it would not affect structural integrity and so a surface treatment may suffice as a solution. There are many processes in use to improve the surface of [9], however, there needs to be consideration of cost and time frame for commercial applications.

Figure 5: Optical image of sintered surface of titanium part, a) inner surface (i) and b) outer surface (ii)

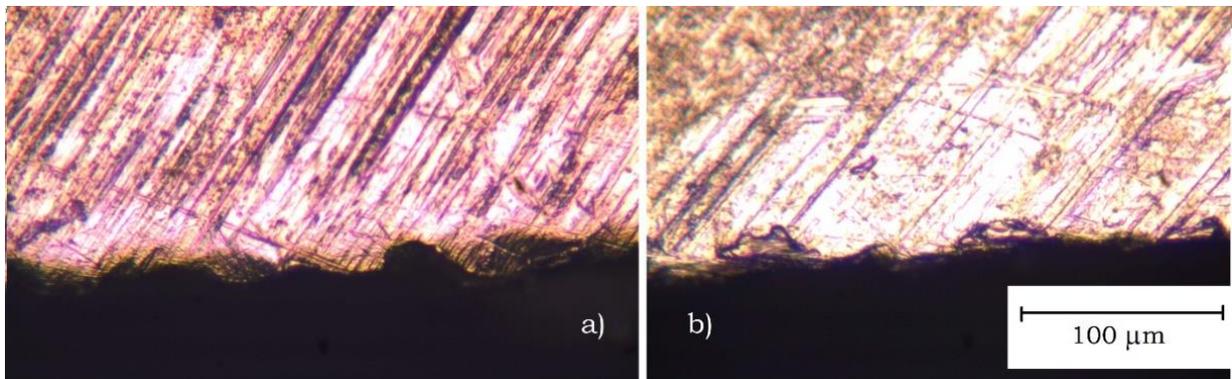
All 10 parts with the visual surface irregularity were inspected and no discernible difference was seen between them. A difference might indicate the irregularities were due to different mechanisms, such as thermal stresses, mechanical abrasion or density distribution. A sample with an average area of irregularity was used for subsequent analysis. When inspected using the optical microscope, it was seen that the inner surface (Figure 5 a) i) has less particles than the outer surface (Figure 5 b) ii). It was considered that this difference in particle distribution may be creating a visual effect. What it did not show, however, was whether this particle deficiency extended through the part's cross section. To address this, the part was sectioned and showed no defects to indicate separation through the part. The cross section shown in Figure 6 a) confirmed the irregularity with fewer particles at the surface, compared to the cross section depicted in Figure 6 b) with regular particle packing, does not visibly extend beyond the surface of the part.

Figure 6: The sectioned parts are seen here as a) irregular surface and b) regular surface

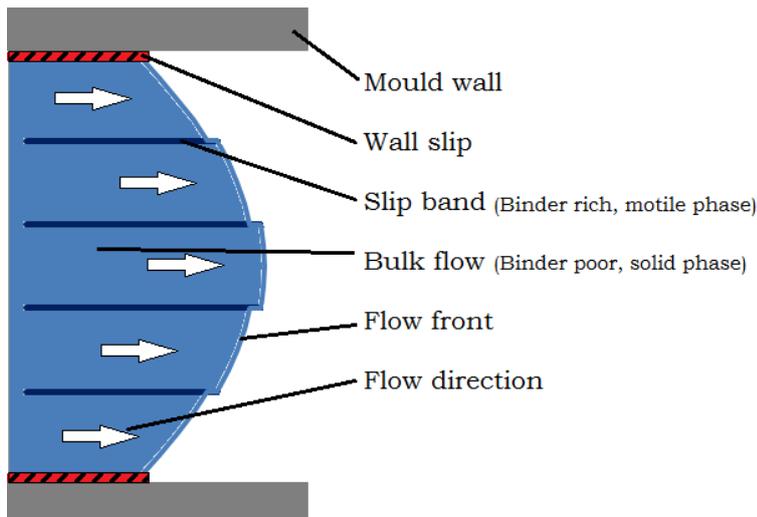
These surface differences can be attributed to the slip phenomena, as seen here in Figure 7, where binder-rich slip bands can form. As seen in Figure 7, the binder-rich layer at the wall surface is thicker than that of the slip bands within the bulk flow [10]. These differences can be accounted for by considering the blend ratio of particles to binder. It is established that a volume fraction of about 0.63 is typical for 45  $\mu\text{m}$  particles. There are number of variables to be considered such as the binder components, the processing temperature, the geometry of the part and geometry changes the flow front is subjected to. These variables can be addressed with flow properties of the feedstock and the stress-strain relation through viscosity.

Figure 7: Slip layers forming due to shear and heat sensitivities during moulding [11]

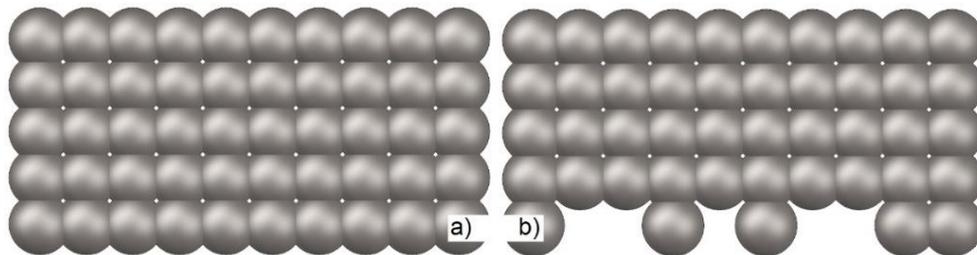
Solid modelling was used to produce a visual representation of what was interpreted in the micrograph in Figure 8. The difference in surface particle distribution was replicated based on a spherical particle model at ~ 93 % consolidation using 2D modelling and shown as Figure 8.

Figure 8: CAD model of a) the regular green part surface and b) the irregular green part surface

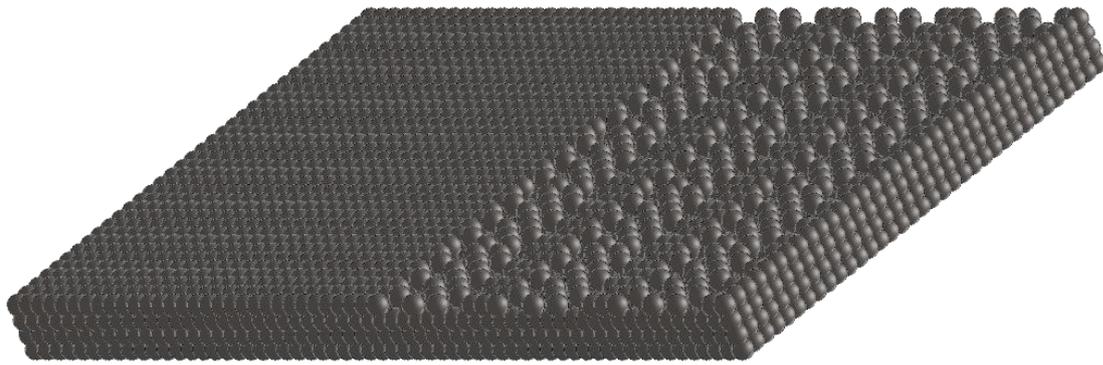
Further depicted in Figure 9 is the clear difference in the visual appearance of the surface, also based on a spherical particle model at ~ 93 % consolidation with a 3D model. While the real surface does not show the regularity as seen here, it is clear from this that a definite 'fingerprint' is formed, which depends on the processing parameters and the equipment (composite tooling) to enable the pattern to be formed. This provides some insight into surface structures and may be a precursor to structural surface creation and the functional aspect that may be enabled by such micro-processes [12].

Figure 9: The solid model of the consolidated particles shows the distinct difference in appearance

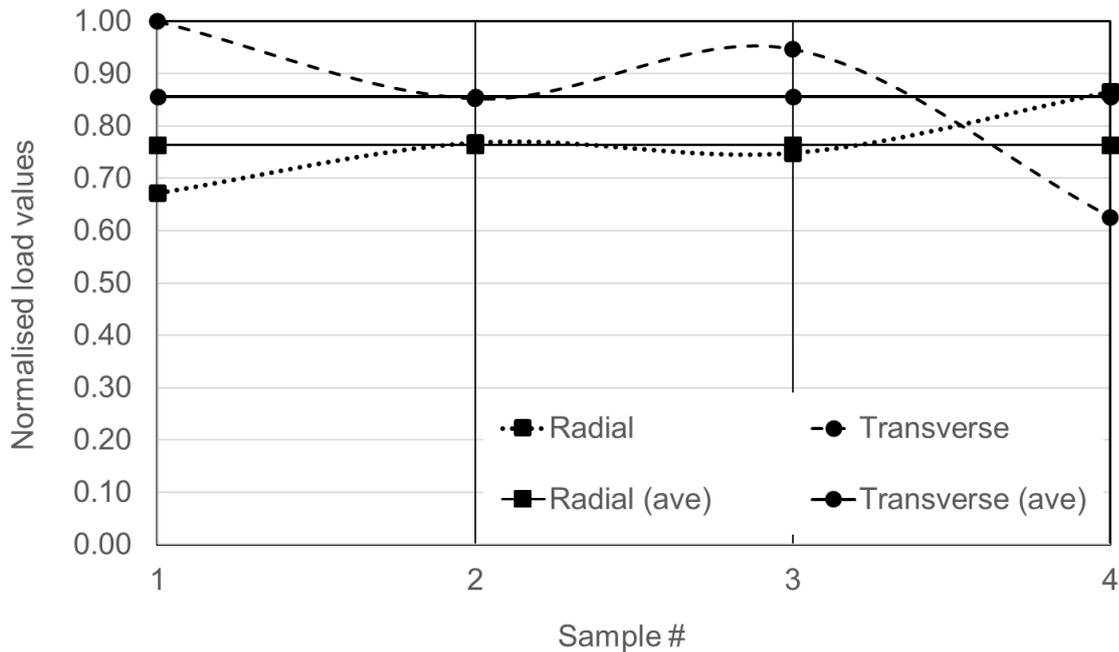
The bend samples were all tested to failure and the load data from both the radial and transverse orientations were normalised to enable comparison. The data in Figure 10 shows a 10 % average load variation between the two orientations. What it does not show, however, is whether the variation is due to the surface irregularity or some other mechanism, such as packing uniformity from a preferential flow set up during moulding. Beam theory would tend to disregard the variation created due to a surface irregularity. Considering that the load to break is a function of the depth of the section, it would take a particle deficiency of more than ten particles ( $45\ \mu\text{m} \times 10$ ) over the section depth ( $d \sim 4.60\ \text{mm}$ ) to create a 10 % load difference [13]. Preferential particle distribution or packing uniformity might prove a better fit to the data.

Figure 10: Normalised load values from three-point bend test of the cut Ti samples

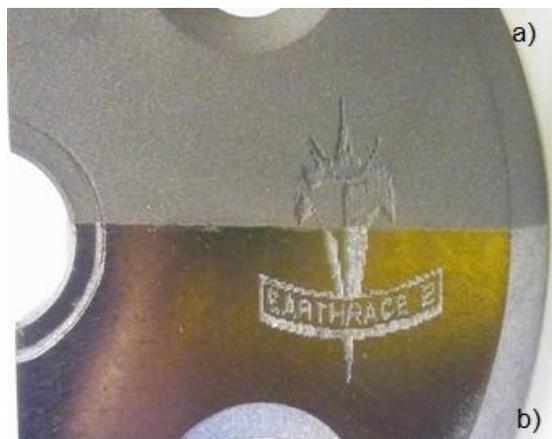
*Figure 11: The part with processed surface: a) sanded and polished and b) bead blasted.*

The first approach to modify the surface was to sand and polish, as seen in *Figure 11 b)*, which removed the irregular appearance and produced a smooth shiny face. This was followed by a grit blasting process, which provided the uniform dull matt surface shown in *Figure 11 a)*.

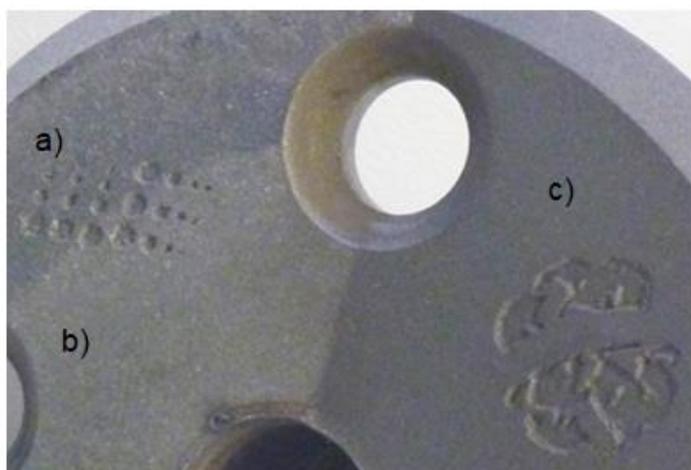
*Figure 12: The sintered part with processed surface: a) and b) the as sintered surface with different visual aspects (irregularity), c) bead blasted surface with uniform appearance*

Secondly, bead blasting (*Figure 12 c)*) was done on the sintered surface (*Figure 12 a) & b)*). The bead blasting process was shown to produce a suitable and acceptable surface. Bead blasting produced the same result, with or without sanding and polishing, so was selected as the final process step eliminating the need for polishing. This ability to remove the irregularity caused by the particle positioning highlights the reflectivity of the titanium particles post sintering also has some part in this effect. This effect will require further investigation to fully explain.

The bead blasting process used a carborundum powder with a particle size in the vicinity of 100 to 400  $\mu\text{m}$ , which could have the effect of reorienting the titanium particle ( $\sim 45 \mu\text{m}$ ) surfaces, hence the uniform appearance [15].
