# Surface irregularities in titanium marine parts formed by the particulate injection moulding process

In this study, a structural hold down component was designed and produced using the particulate injection moulding (PIM) process. The material of choice was titanium due not only to the material properties but also due to the desire to create custom-made components for a state-of-the-art marine vessel, Earthrace 2.

On removal from the mould, the green parts were seen to have an irregular surface on the top face. Known as surface bloom, it can be seen during moulding of single-phase commodity polymers as a result of changes in the polymer density, due to shear stresses and irregularities of turbulent flow.

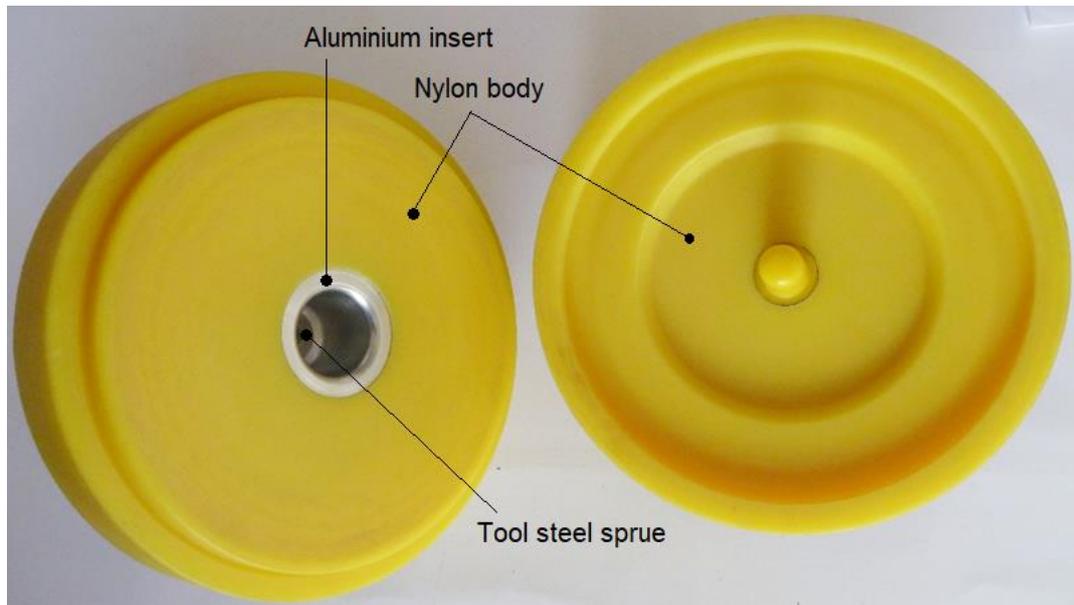
Figure 2: Composite tool insert produced using polyamide (nylon), aluminium and tool steel, suitable for production run < 100 parts

Two material properties that are considered to influence the moulding behaviour in this case are thermal expansion of the feedstock and thermal conductivity of the tooling. The feedstock effect will be seen where temperature variations produce volume change in the thermoplastic binder, increasing the likelihood of separation as the optimised ratio is only realised for a given temperature. The tooling effect will be exacerbated by the composite tooling whereby the thermal conductivity of the mould wall changes as the materials changes, as seen in Figure 2.
